# CHASING PICOFARADS

## Troubleshooting Capacitive Fuel Indication Systems

BY BRAD PRIMM

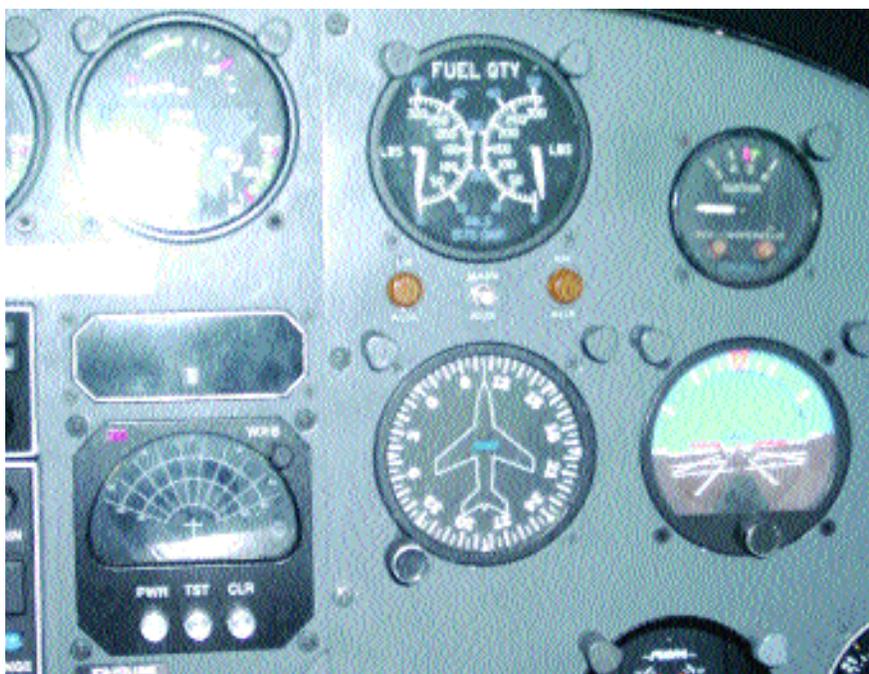
**The problem.** A new customer with a 1973 Cessna 340 came to the shop with a carefully prepared, single-spaced, type written note explaining his fuel quantity problems. The problems included, but were not limited to, intermittent or erratic readings on all tanks, the right aux tank never reads more than two thirds full, and the quantity of the right main tank somehow influences the reading of the right aux tank. The customer had the aircraft to several maintenance shops and one even replaced the entire main wiring harness in the wings in an effort to fix the problems. The cus-

*Cessna 340 fuel quantity indicator*

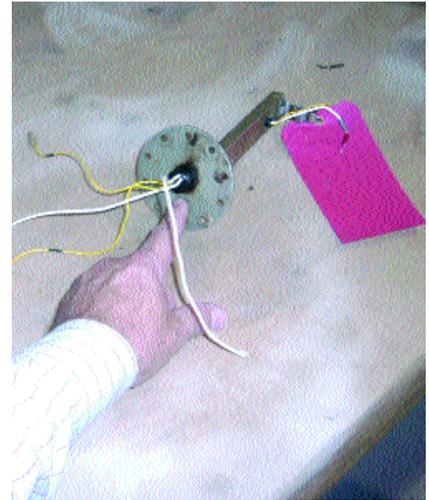
*Defective potted feed-through on stand-off assembly.*

The resistance checks revealed numerous problems on both sides. Troubleshooting the wiring, our persistent avionics technician found the harness section for the inner aux tank, on the right hand side, was reading less than 10 megohms. This was the probe that was just replaced! After the mechanics extracted the probe assembly again for further testing, he found the splice in the potted feed-through was bad and not field repairable. A new harness and standoff assembly

was ordered and installed. The probe was reused. Also, on the left side, the main tank pigtail harness was reading less than 900 megohms. Redoing a splice in one of the lines repaired this problem. On both sides, the harnesses were carefully inspected and all of the Cessna quick-disconnects for the probe harnesses were cleaned and retentioned.

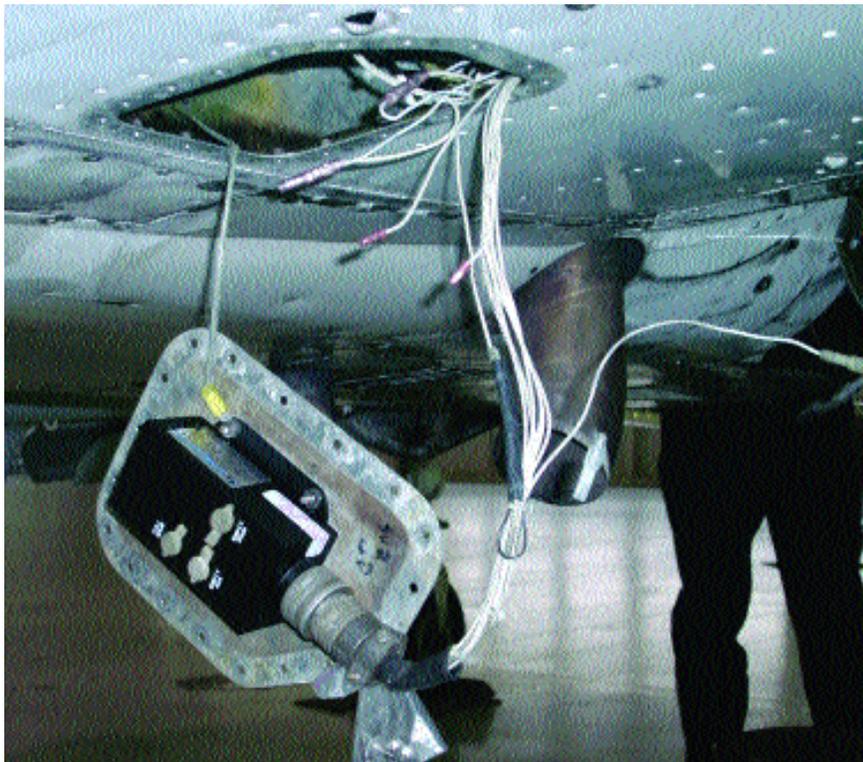
*Signal Conditioner, note the adjustments marked on case.*

tagged signal conditioners and fuel gage. Our avionics technician went into the cockpit, played around with the circuit breakers, and the right side would occasionally come alive. The breakers had already been replaced; could the mechanics have put in another bad breaker? Slim chance. What if the power spikes to the signal conditioner from exercising the breakers were “shocking” it into submission? A quick swap of signal conditioners revealed that the freshly repaired, right side conditioner’s 8130-3 wasn’t worth the paper it was printed on and back to the shop it went.

Our Caped Crusader also found a broken shield for the main tank HI-Z shielded wire at the R/H signal conditioner plug. In the meantime, the signal conditioner came back from the shop with another proud 8130-3 and an explanation that there were intermittent connections on the internal PC board.
