Aircraft Wiring Incidents Persist In Aging Systems

The U.K. Air Accidents Investigation Branch cited four recent incidents in which wiring problems were associated with aging aircraft electrical systems and/or maintenance issues.

FLIGHT SAFETY FOUNDATION EDITORIAL STAFF

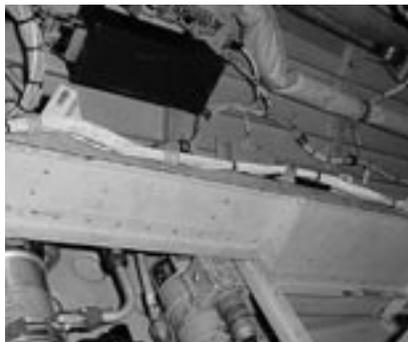
had occurred in an area inside the ceiling panel where a braided-steel hose (a water hose that delivered water from the crown of the fuselage to the galley on the right side of the forward cabin) had been secured with a nylon electrical tie-wrap strap.

The report said, "It appeared that there had been abrasion and arcing between the wires and the hose, resulting in the severing and shorting of a number of the wires. The braided-steel hose was lying against the frame of the ceiling panel, and it appeared that there had also been electrical shorting to this portion of the airframe."

In one section of the hose, the steel braid had melted, and at least two holes had formed in the inner hose, resulting in the water leak.

"Comparison with a sister aircraft ... indicated that the hose was too long for this application and that the extra length ... had been looped through this overhead area and then only secured by a tie-wrap to adjacent wire bundles," the report said. "Part of the hose was protected by plastic spiral wrap, but this did not extend to the portion of the hose in contact with the wire bundles."

- "The excessive length of the steel-braided water hose to the forward galley;
- "The lack of an established routing or restraint of this extra hose; and,
- "The unexplained securing of this hose to the electrical loom."

Based on the findings of the incident investigation, AAIB recommended that Boeing Commercial Airplanes review the section of the maintenance manual that provides information about the installation of the forward galley in the B-737-400 and other affected models "to give clear instruction as to where the galley water-supply hose disconnection should be made when removing the galley" for maintenance.
