Aircraft Wiring Incidents Persist In Aging Systems

The U.K. Air Accidents Investigation Branch cited four recent incidents in which wiring problems were associated with aging aircraft electrical systems and/or maintenance issues.

FLIGHT SAFETY FOUNDATION EDITORIAL STAFF

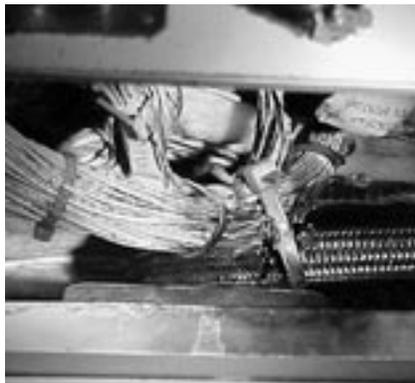
In the first incident, the flight crew of a Boeing 737-400 observed smoke and detected the odor of electrical burning soon after departure on Nov. 8, 2002, from London (England) Heathrow Airport for a flight to Kiev, Ukraine. Six crew members and 68 passengers were in the airplane. The cabin-call aural

The flight crew flew the airplane back to Heathrow where they conducted a precautionary landing, stopped the airplane on the runway and shut down the engines to allow an inspection of the airplane by aircraft rescue and fire fighting (ARFF) personnel. The visual inspection revealed no fire or damage, and thermal imaging revealed no hot areas in the airplane’s ceiling; nevertheless, the report said, “on pulling down the damaged ceiling panel [just outside the flight deck door], a [burned] wiring loom [bundle of wires] could be seen. Next to this was the water-supply hose to the forward galley, from which water was still pouring.”

In one section of the hose, the steel braid had melted, and at least two holes had formed in the inner hose, resulting in the water leak.

Based on the findings of the incident investigation, AAIB recommended that Boeing Commercial Airplanes review the section of the maintenance manual that provides information about the installation of the forward galley in the B-737-400 and other affected models "to give clear instruction as to where the galley water-supply hose disconnection should be made when removing the galley" for maintenance.
